## Determination of Scuffing Resistance

Report Number: **T16/405S**

**Client:** **BBA** **Lab. Scheme Number:** **2287**  
**BBA Identification** **S159487**  
**Installer:** **Leeson Polyurethanes** **BBA Sample No** **n/a**  
**Product for test:** **PU4844/60 Part A and B Autumn Gold 5mm Resin Bound Surfacing**  
**Binder type:** **Polyurethane** **Batch No. Binder:** **Part A PU4844/60**  
**Part B PU4844/60**  
**Aggregate type:** **Autumn Gold 5mm** **Batch No.** **n/a**  
**Date of application** **n/a** **Date received** **18-Oct-16**  
**Location of Installation:** **Leeson Polyurethanes**

## Test Method: Determination of scuffing, TRL 176 Appendix G

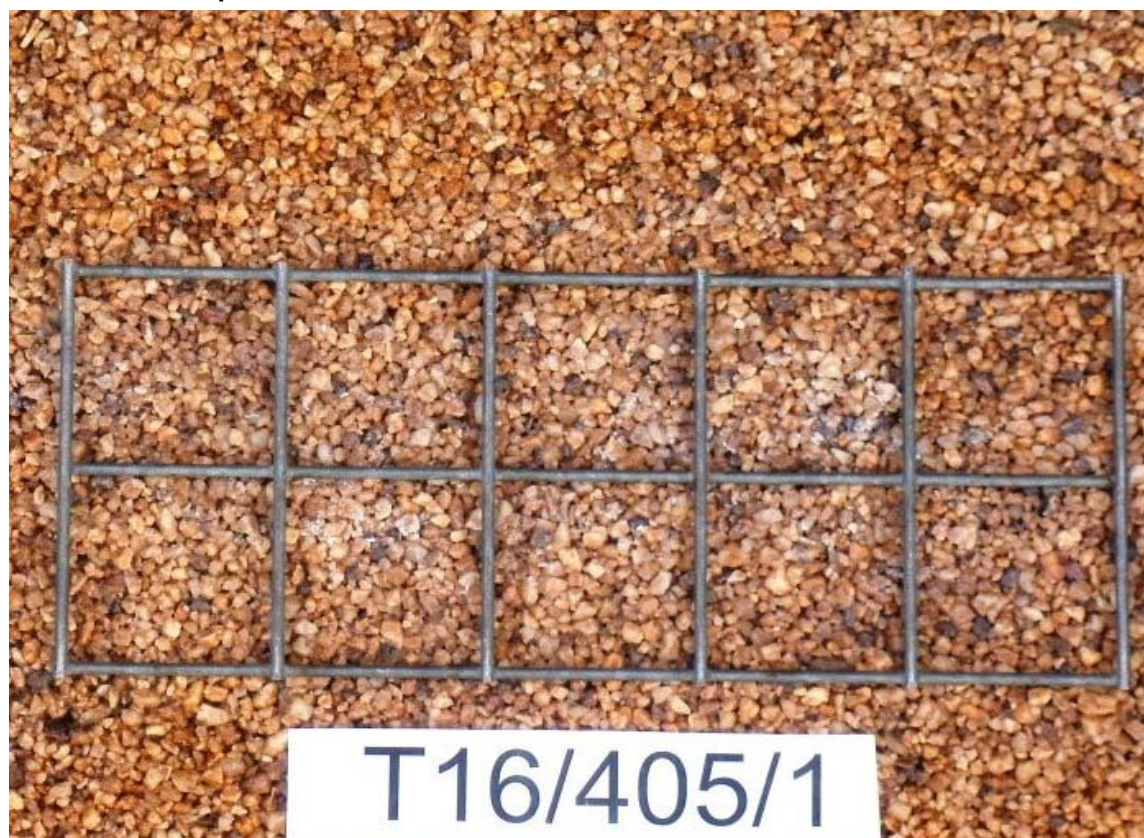
Specimen Number	<b>405S</b>	
Identification of slab	<b>1</b>	
SRV before Scuffing (slider 57)	<b>54</b>	
SRV before Scuffing (slider 96)	<b>56</b>	
Date of test	<b>25/10/2016</b>	
Time of test	<b>15:45</b>	
Test Temperature (°C)	<b>45.0</b>	
Tyre Pressure (Bar)	Initial	<b>3.1</b>
	Final	<b>3.1</b>
Tyre tread depth (mm)	Initial	<b>1.2</b>
	Final	<b>1.2</b>
Angle of Tyre to direction of travel	<b>20°00'</b>	
SRV after Scuffing (slider 57)	<b>67</b>	
SRV after Scuffing (slider 96)	<b>58</b>	
Surface texture depth (mm)	Initial	<b>1.70</b>
	Final	<b>1.55</b>
Loss of texture depth (%)	<b>8.8</b>	
Erosion Index	<b>0.0</b>	
Description of visual condition	<b>No faults or anomalies were observed</b>

After 500 wheel passes at 45°C

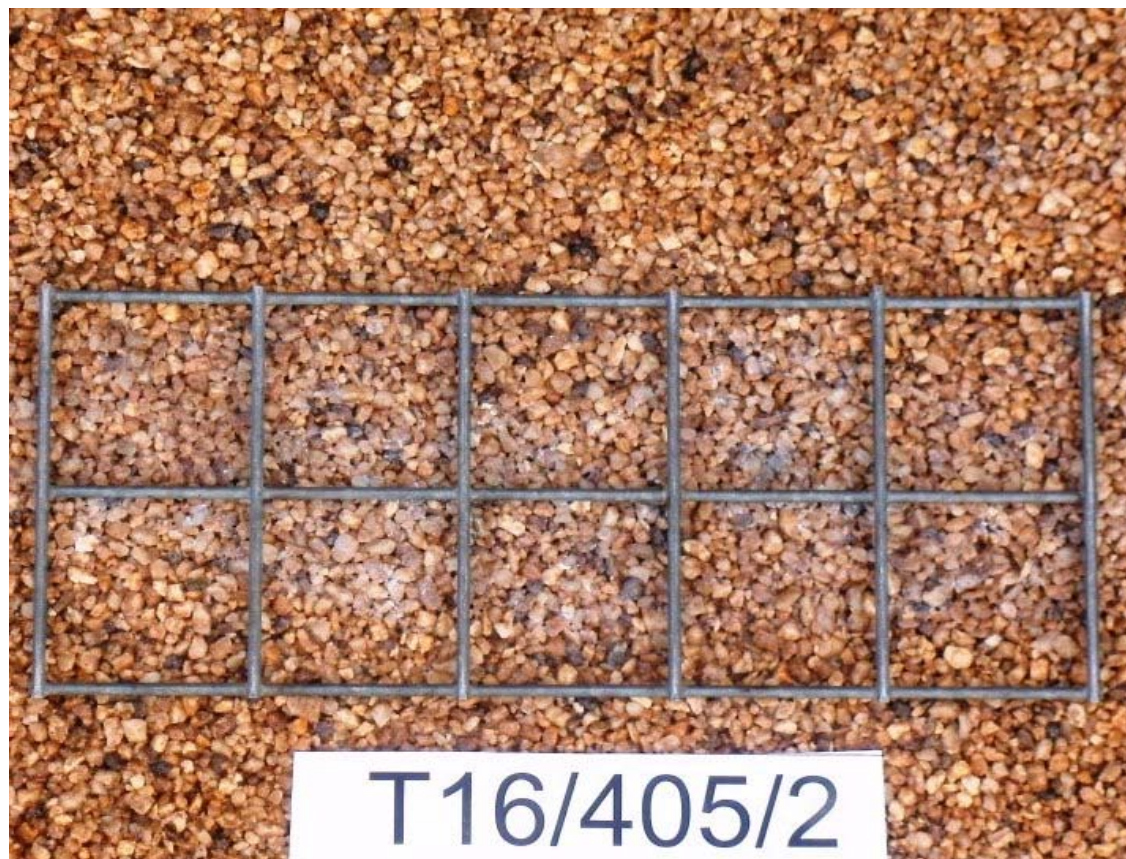
Specimen Number	<b>405S</b>	
Identification of slab	<b>2</b>	
SRV before Scuffing (slider 57)	<b>50</b>	
SRV before Scuffing (slider 96)	<b>53</b>	
Date of test	<b>25/10/2016</b>	
Time of test	<b>15:25</b>	
Test Temperature (°C)	<b>45.0</b>	
Tyre Pressure (Bar)	Initial	<b>3.1</b>
	Final	<b>3.1</b>
Tyre tread depth (mm)	Initial	<b>1.2</b>
	Final	<b>1.2</b>
Angle of Tyre to direction of travel	<b>20°00'</b>	
SRV after Scuffing (slider 57)	<b>50</b>	
SRV after Scuffing (slider 96)	<b>53</b>	
Surface texture depth (mm)	Initial	<b>1.43</b>
	Final	<b>1.31</b>
Loss of texture depth (%)	<b>8.4</b>	
Erosion Index	<b>0.0</b>	
Description of visual condition	<b>No faults or anomalies were observed</b>

After 500 wheel passes at 45°C

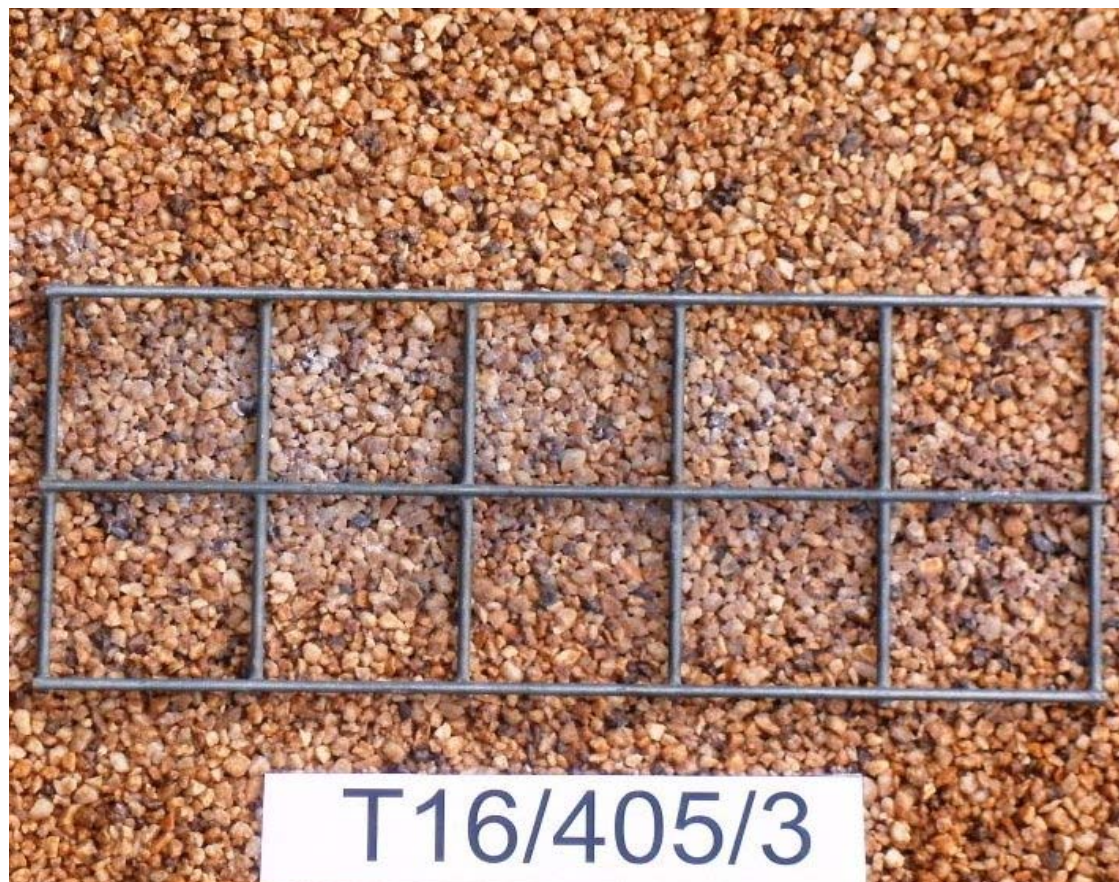
Specimen Number		<b>405S</b>
Identification of slab		<b>3</b>
SRV before Scuffing (slider 57)		<b>47</b>
SRV before Scuffing (slider 96)		<b>50</b>
Date of test		<b>25/10/2016</b>
Time of test		<b>15:10</b>
Test Temperature (°C)		<b>44.8</b>
Tyre Pressure (Bar)	Initial	<b>3.1</b>
	Final	<b>3.1</b>
Tyre tread depth (mm)	Initial	<b>1.2</b>
	Final	<b>1.2</b>
Angle of Tyre to direction of travel		<b>20°00'</b>
SRV after Scuffing (slider 57)		<b>52</b>
SRV after Scuffing (slider 96)		<b>53</b>
Surface texture depth (mm)	Initial	<b>1.3</b>
	Final	<b>1.3</b>
Loss of texture depth (%)		<b>3.0</b>
Erosion Index		<b>0.0</b>
Description of visual condition		<b>No faults or anomalies were observed</b>

After 500 wheel passes at 45°C
