Determination of Scuffing Resistance

Report Number: **T16/406S**

Client: **BBA** Lab. Scheme Number: **2287**
 BBA Identification: **S159487**
 Installer: **Leeson Polyurethanes** BBA Sample No: **n/a**
 Product for test: **PU4844/60 Part A and B Trent Pea 3mm Resin Bound Surfacing**
 Binder type: **Polyurethane** Batch No. Binder: **Part A PU4844/60**
Part B PU4844/60
 Aggregate type: **Trent Pea 3mm** Batch No. **n/a**
 Date of application **n/a** Date received **18-Oct-16**
 Location of Installation: **Leeson Polyurethanes**

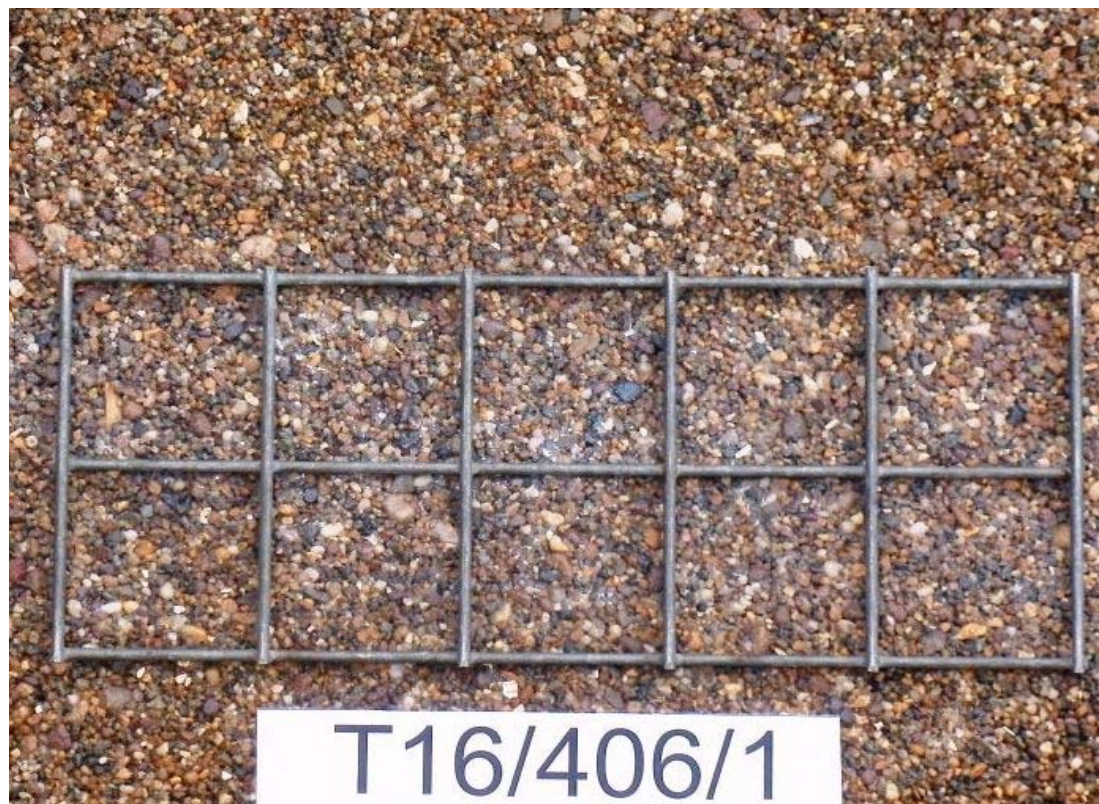
Specimen Number	406S	
Identification of slab	1	
SRV before Scuffing (slider 57)	46	
SRV before Scuffing (slider 96)	47	
Date of test	25/10/2016	
Time of test	09:50	
Test Temperature (°C)	44.9	
Tyre Pressure (Bar)	Initial	3.1
	Final	3.1
Tyre tread depth (mm)	Initial	1.3
	Final	1.3
Angle of Tyre to direction of travel	20°00'	
SRV after Scuffing (slider 57)	48	
SRV after Scuffing (slider 96)	47	
Surface texture depth (mm)	Initial	0.68
	Final	0.62
Loss of texture depth (%)	8.8	
Erosion Index	0.0	
Description of visual condition	No faults or anomalies were observed

After 500 wheel passes at 45°C

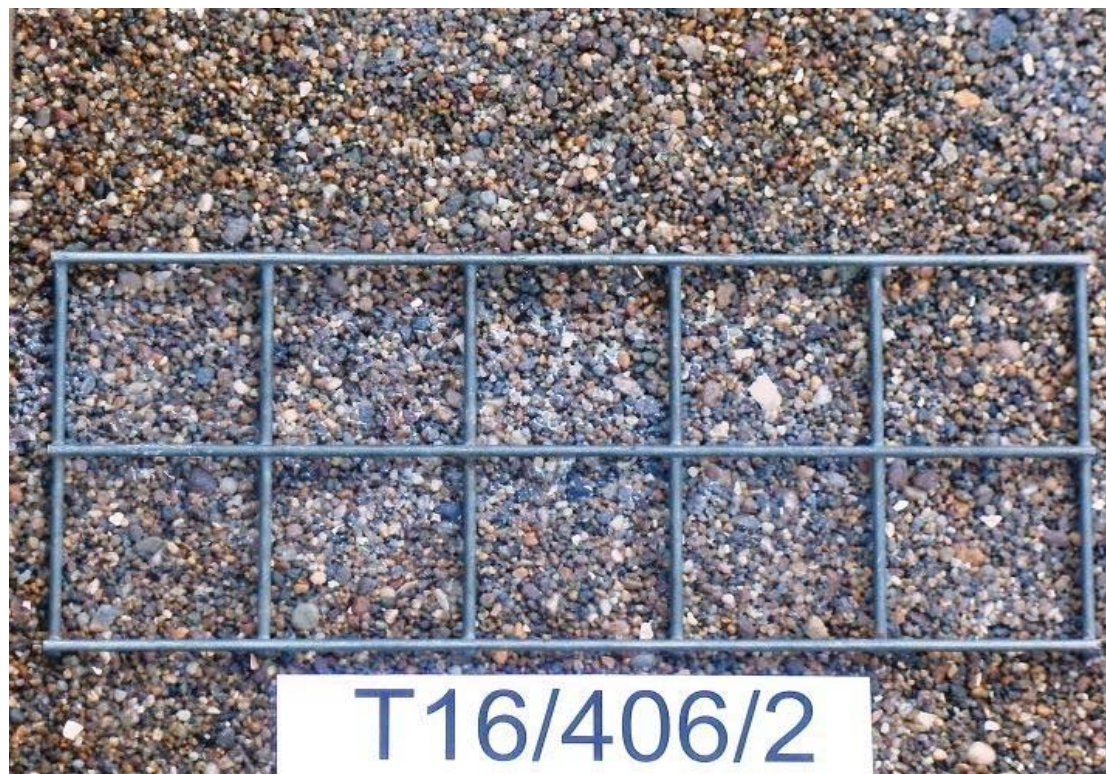
Specimen Number	406S	
Identification of slab	2	
SRV before Scuffing (slider 57)	50	
SRV before Scuffing (slider 96)	55	
Date of test	25/10/2016	
Time of test	14:40	
Test Temperature (°C)	44.7	
Tyre Pressure (Bar)	Initial	3.1
	Final	3.1
Tyre tread depth (mm)	Initial	1.3
	Final	1.2
Angle of Tyre to direction of travel	20°00'	
SRV after Scuffing (slider 57)	48	
SRV after Scuffing (slider 96)	55	
Surface texture depth (mm)	Initial	0.80
	Final	0.77
Loss of texture depth (%)	3.8	
Erosion Index	0.0	
Description of visual condition	No faults or anomalies were observed

After 500 wheel passes at 45°C

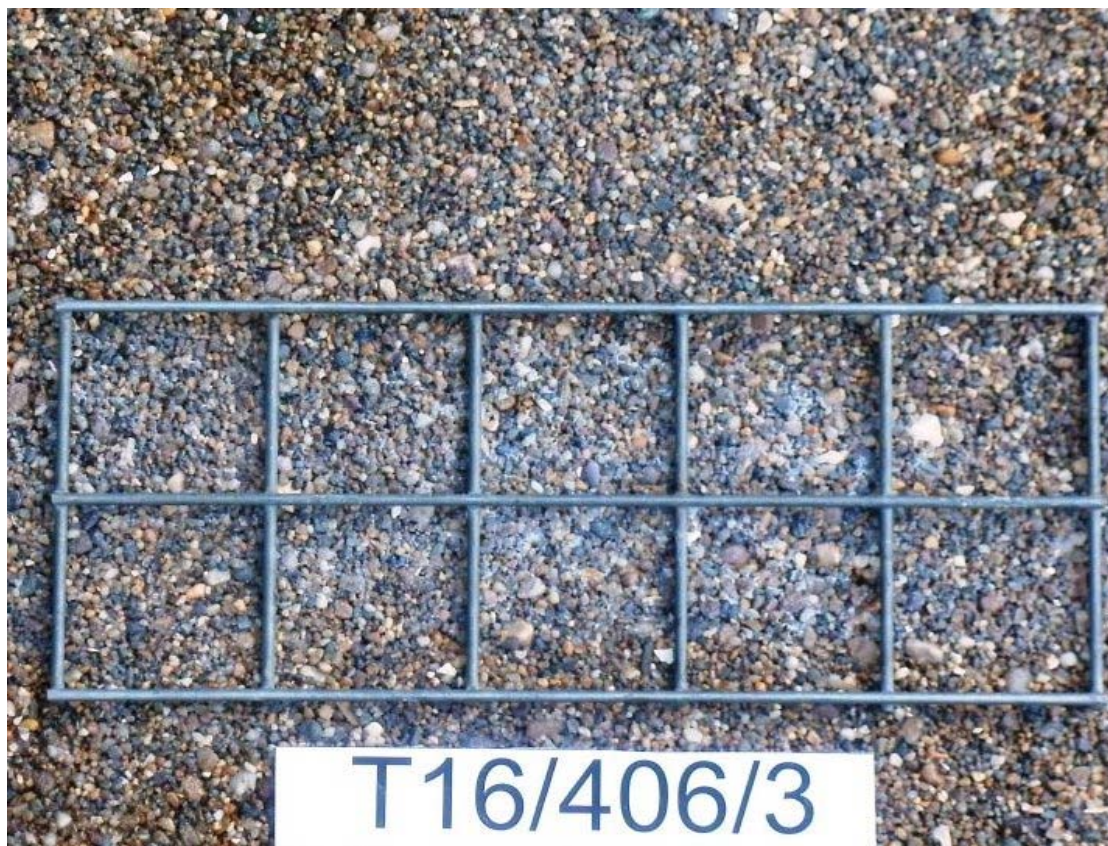
Specimen Number	406S	
Identification of slab	3	
SRV before Scuffing (slider 57)	51	
SRV before Scuffing (slider 96)	54	
Date of test	25/10/2016	
Time of test	14:55	
Test Temperature (°C)	45.0	
Tyre Pressure (Bar)	Initial	3.1
	Final	3.1
Tyre tread depth (mm)	Initial	1.2
	Final	1.2
Angle of Tyre to direction of travel	20°00'	
SRV after Scuffing (slider 57)	49	
SRV after Scuffing (slider 96)	54	
Surface texture depth (mm)	Initial	0.8
	Final	0.7
Loss of texture depth (%)	11.5	
Erosion Index	0.0	
Description of visual condition	No faults or anomalies were observed

After 500 wheel passes at 45°C
